# Barrier EIFS Stucco Inspection Report

**Property Address:**  
1234 Pine Lane  
Anywhere, CO 80121

**Huffman Inspections Colorado, Inc.**

| <b>Date:</b> 5/28/2026 | <b>Time:</b> 08:00:00 AM | <b>Report ID:</b> 20260528JM1 |

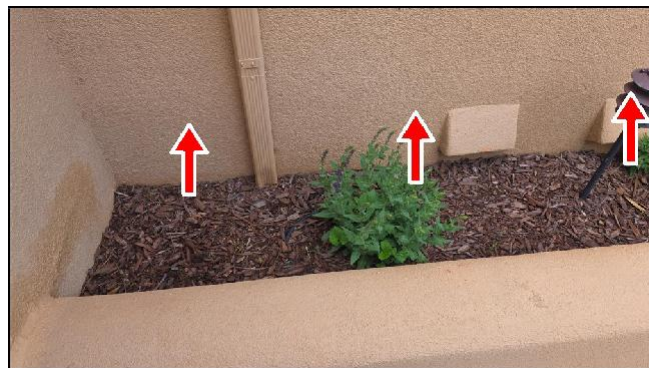
- The walls are below grade in several locations. EIFS walls should finish four inches above grade (landscaping). To resolve this issue, the landscaping needs to be rearranged so the foundation is exposed or the bottom of the walls raised. See detail 3.6.

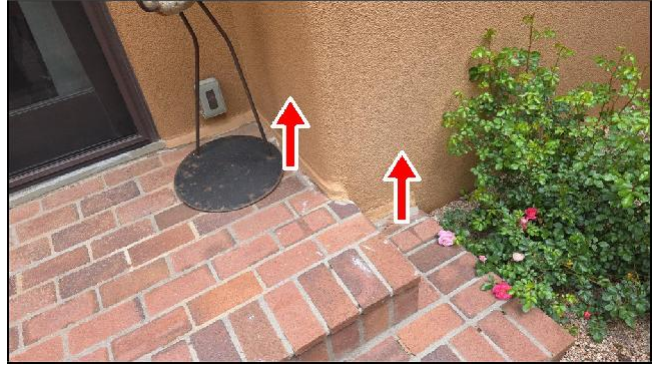
- The EIFS walls are in contact with the concrete slabs. This was a typical construction technique at the time this home was built. The EIFS manufacturer's call for the EIFS walls to finish 2 inches above all hard surfaces, concrete slabs. Where the walls are on/below concrete slabs, they should be raised. If wood is exposed in the process of raising the walls, weather proofing and metal flashing will need to

be added to protect the wood. Due to the damage at the bottom of the system from it is recommended to raise the bottom of the system then properly finish the bottom of the system.

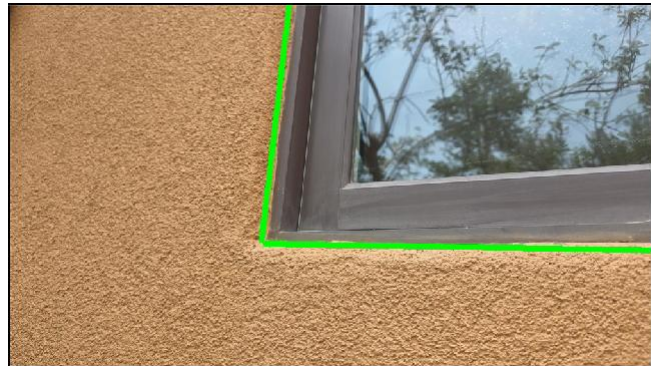
- Existing sealant appears to be aged, cracked, missing, or improper to prevent moisture intrusion at doors and windows; properly seal **ALL** windows/doors making sure to keep **ALL** weep holes unobstructed.

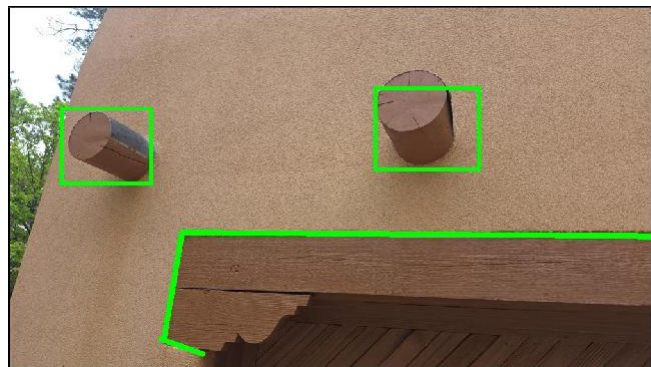
- Existing sealant appears to be aged, cracked, missing, or improper to prevent moisture intrusion at dissimilar materials; properly seal **ALL** joints between dissimilar materials.

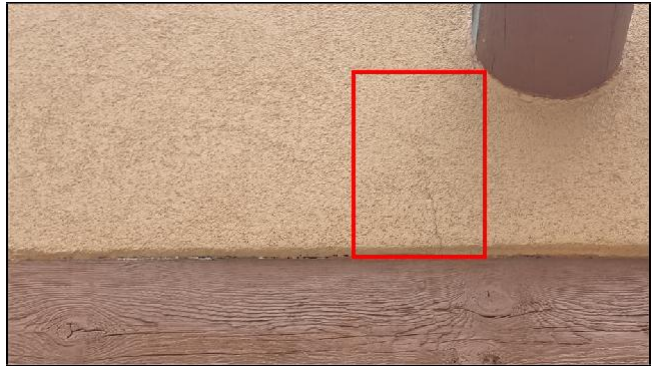
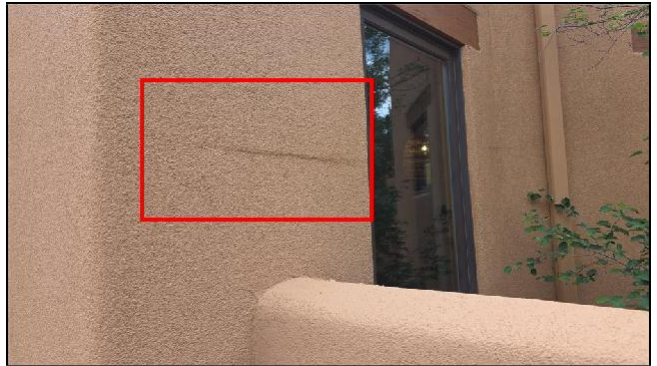
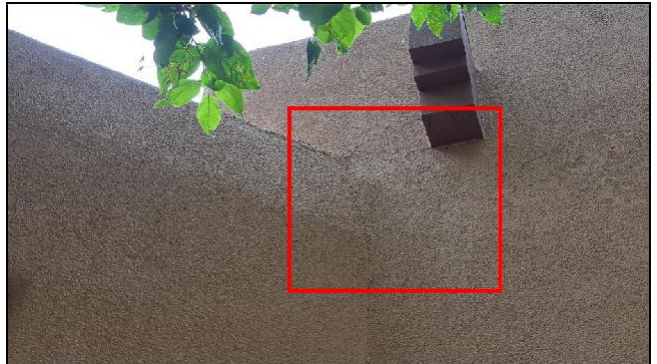
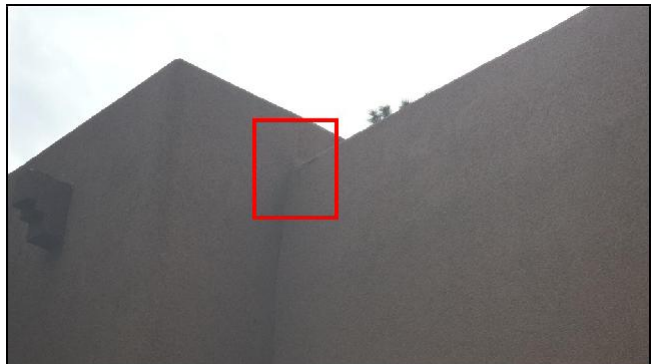
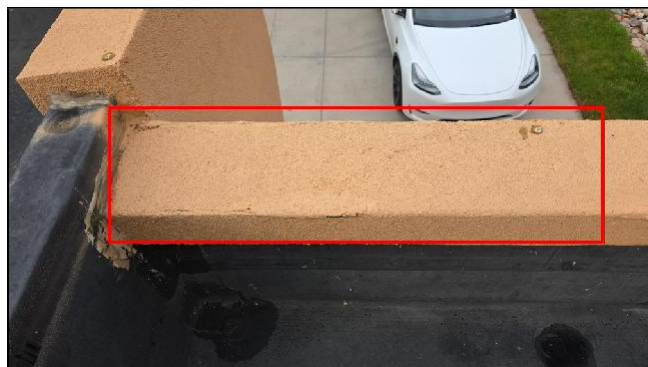
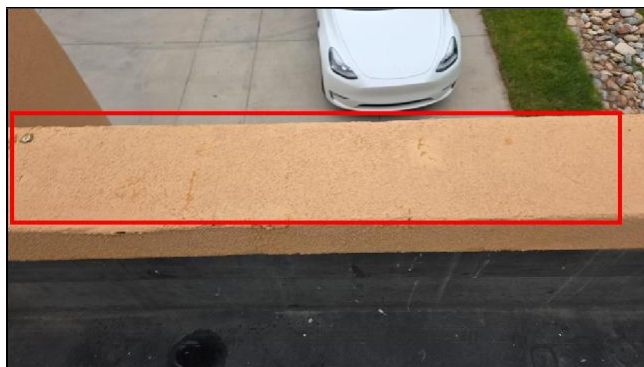
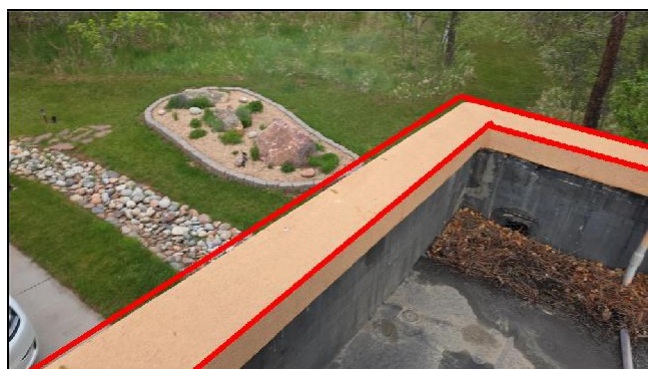
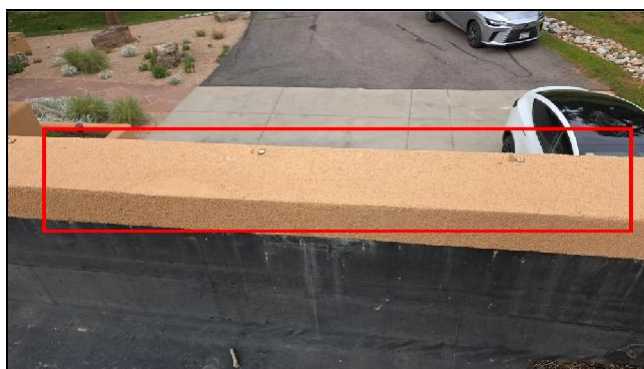
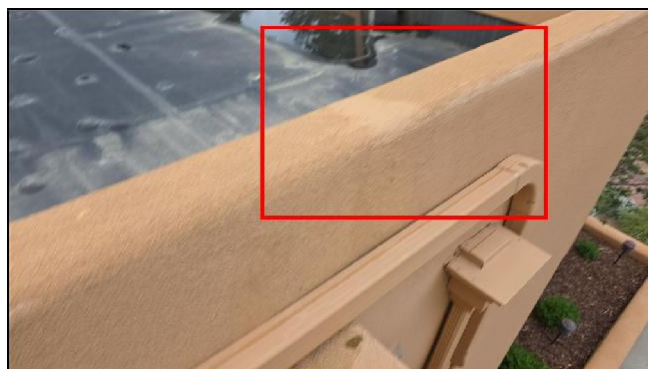
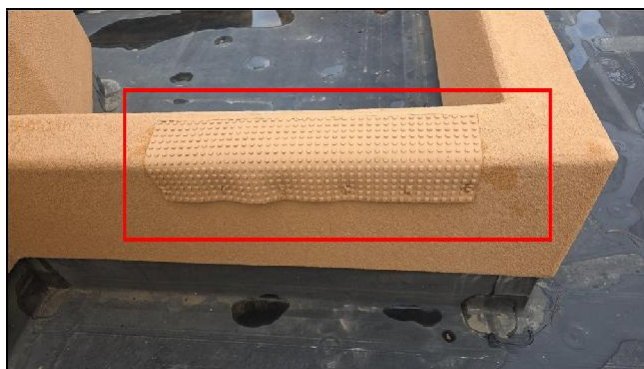
- **Damage, impact damage or exposed cracks** were noted in areas. These areas and any others discovered during repairs should be repaired to help prevent moisture intrusion. Chapter 2.

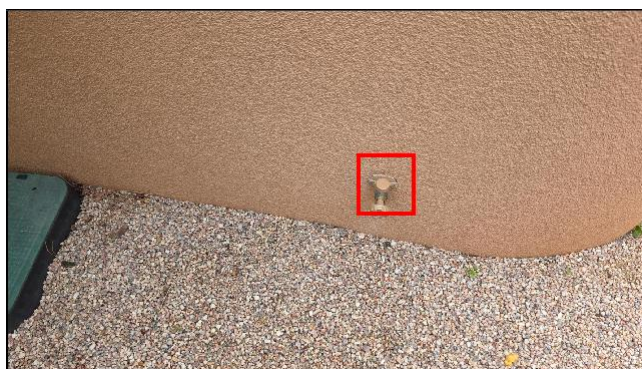
- Various devices were attached to the stucco without the use of a proper stand-off, this can cause **damage** in areas and increases the likelihood of water intrusion; repair damage and install proper stand-offs.

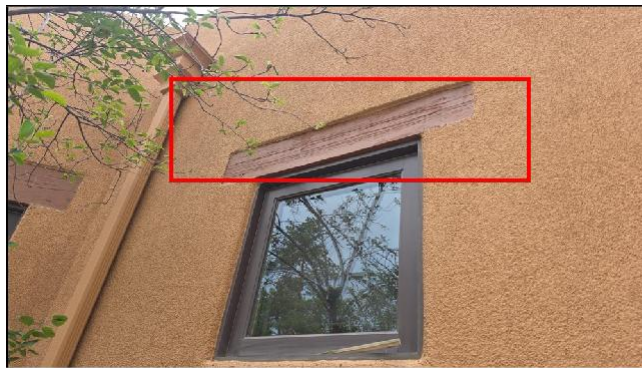
- Wood inlays appeared to be aged and dried out, these may also create avenues for moisture intrusion; remove and repair areas with stucco then properly seal all joints created.

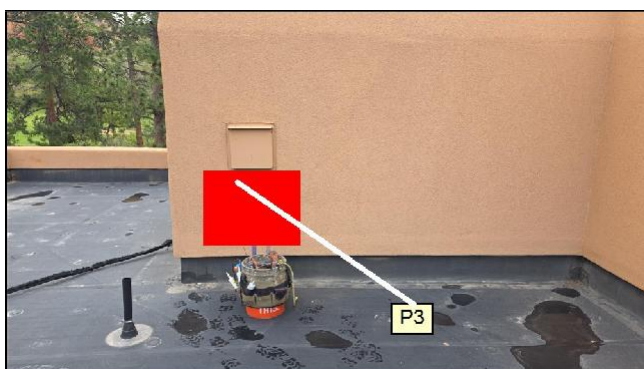
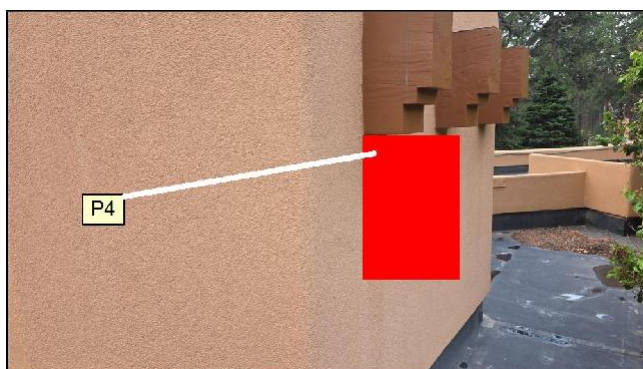
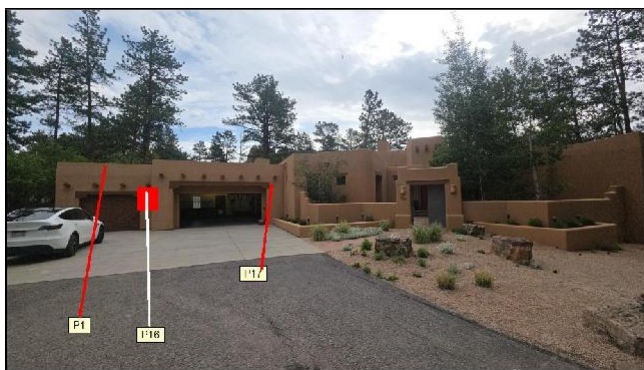
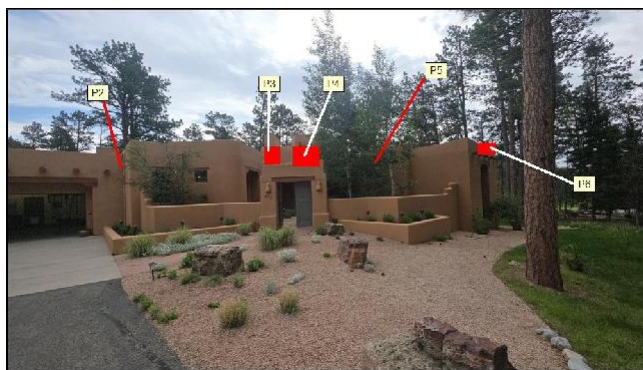
- All **RED OUTLINED/SHADED AREAS** are indication of probable deterioration; further investigation is required.

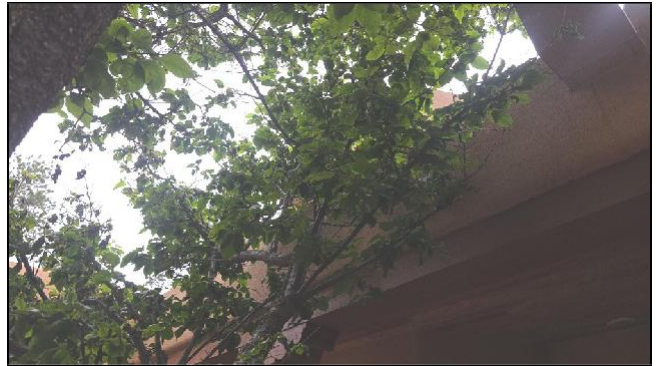
- All shrubbery and vegetation should be pruned back 18-24 inches from the house as it retains moisture in the immediate area and inhibits its evaporation.

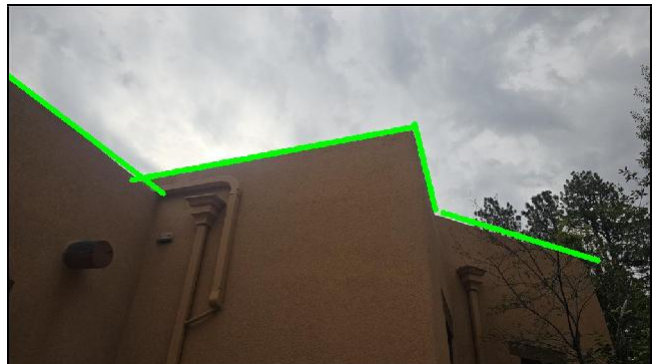
- Parapet wall or column cap flashing should cover the entire top of the parapet walls and column caps to protect wall cladding from moisture intrusion. As an alternative, if the client is willing to accept some additional risk of impact damage, the tops of the parapet walls and column caps may be sloped and protected with a double application of water proof base coat with embedded fiberglass reinforcement in each layer. Then apply a water proof finish coat. Finally, monitor and maintain the tops of the parapet walls and column caps. See detail 3.12.

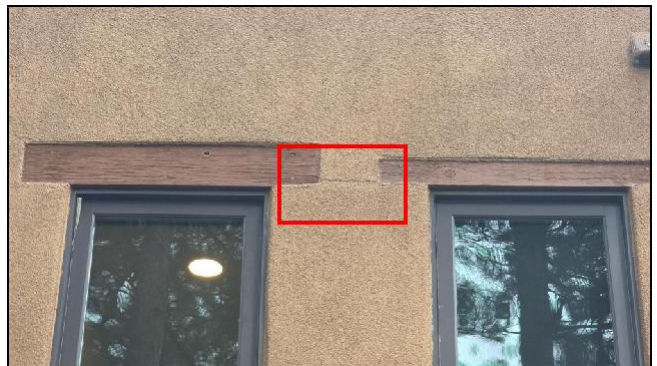
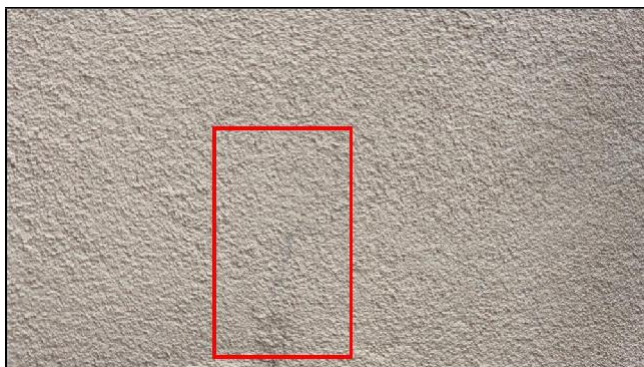
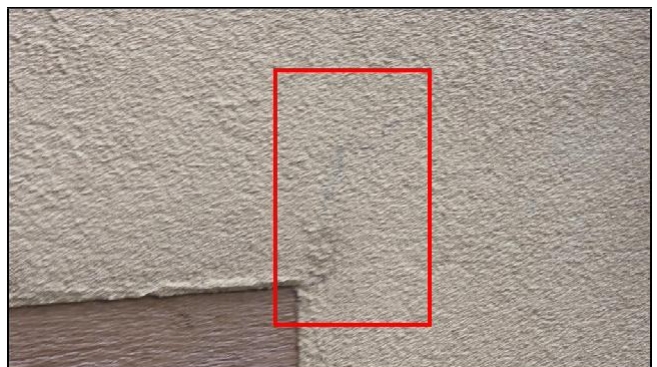
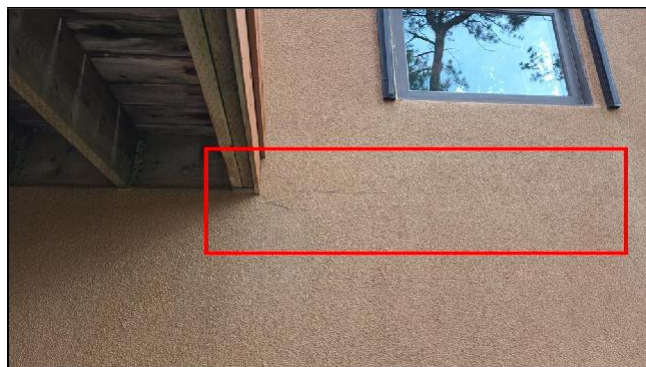
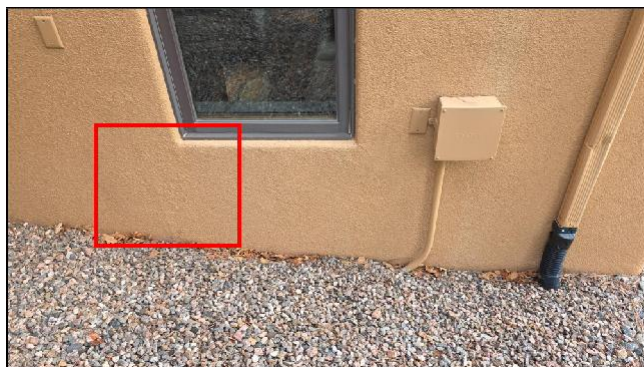
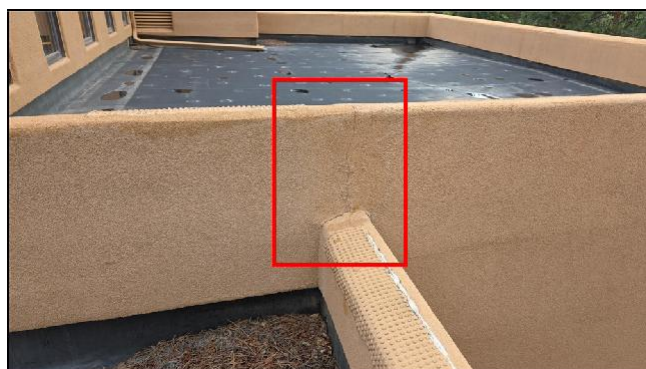
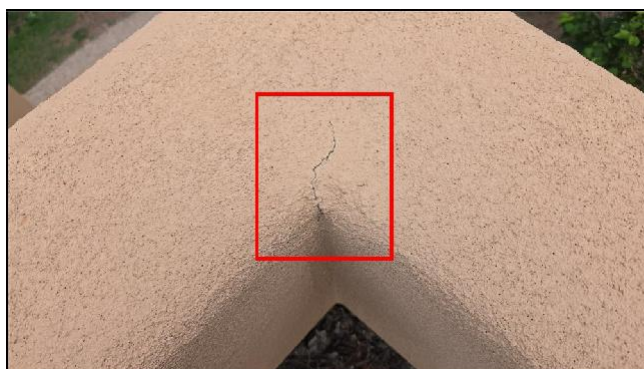
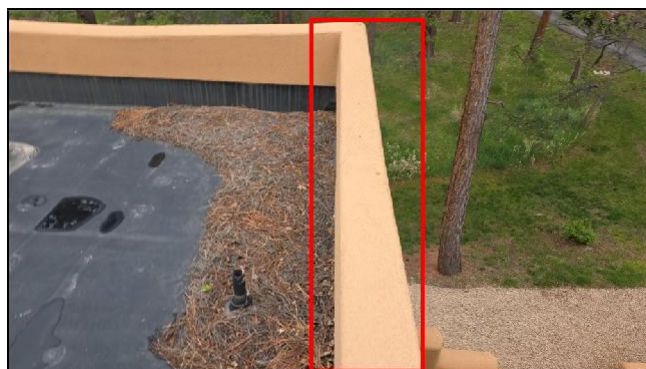
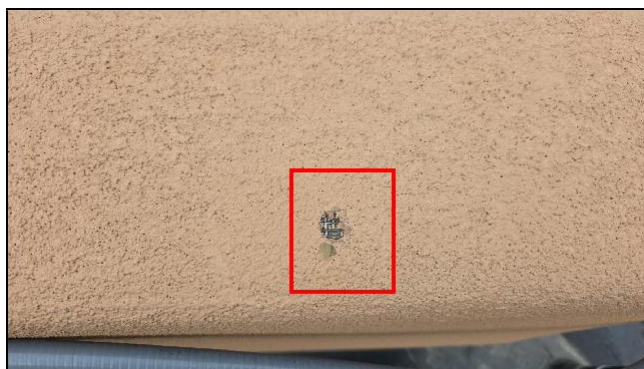
- Damage, impact damage or exposed cracks** were noted in areas. These areas and any others discovered during repairs should be repaired to help prevent moisture intrusion. Chapter 2.

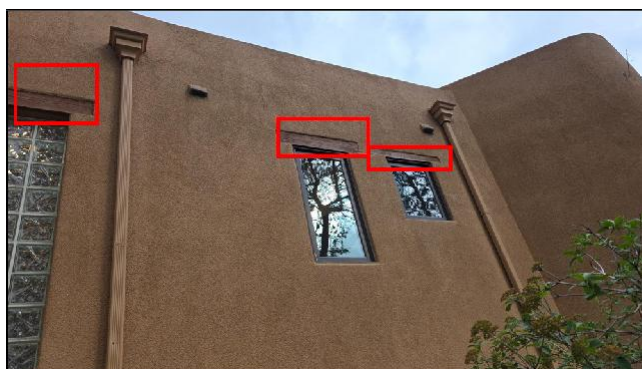
- Wood inlays appeared to be aged and dried out, these may also create avenues for moisture intrusion; remove and repair areas with stucco then properly seal all joints created.

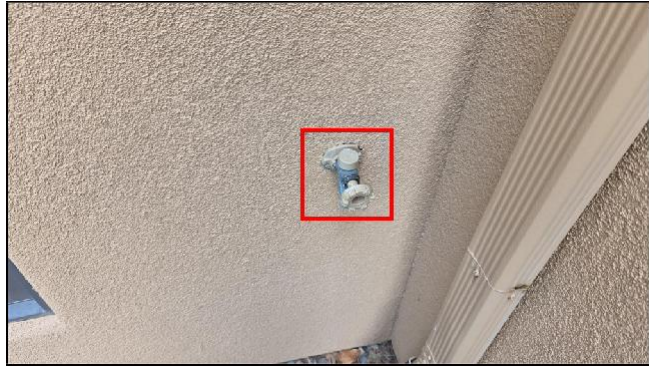
- The wall was finished around the hose bib, this can create an avenue for water intrusion. Trim back wall and install a proper stand-off then seal all created joints.

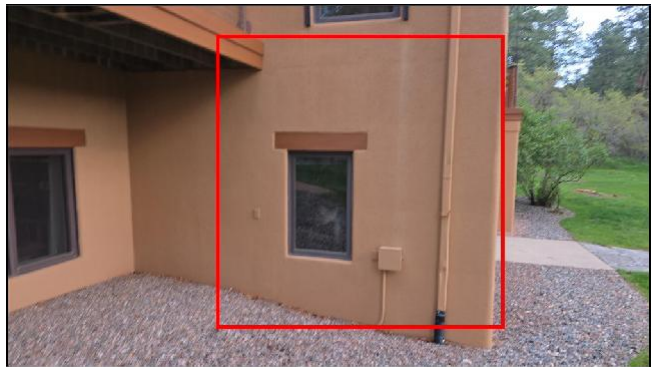
- Seams between EPS panels were visible through the finish coat; repair and sealant any joints created during repairs.

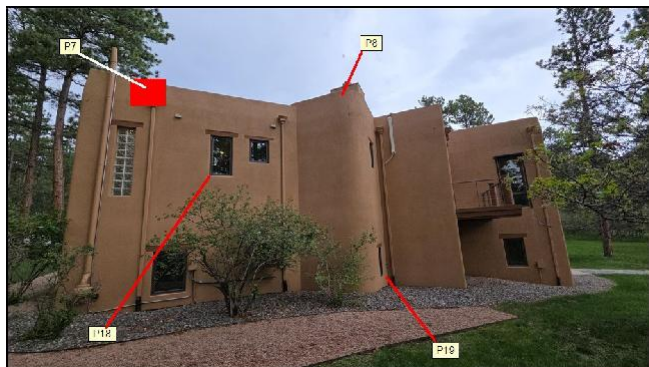
- All **RED OUTLINED/ SHADED AREAS** are indication of probable deterioration; further investigation is required.

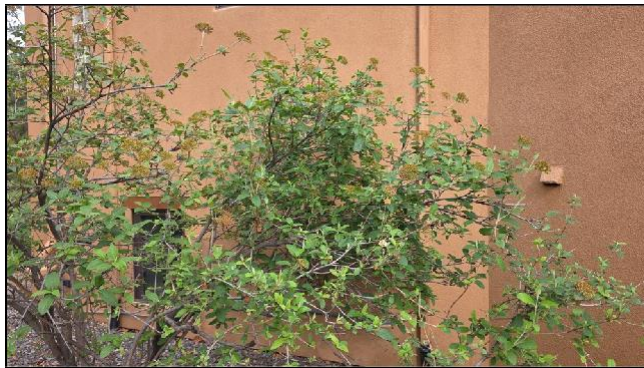
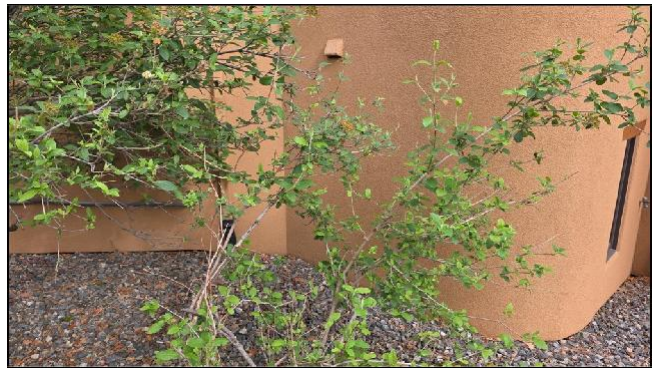
- All shrubbery and vegetation should be pruned back 18-24 inches from the house as it retains moisture in the immediate area and inhibits its evaporation.

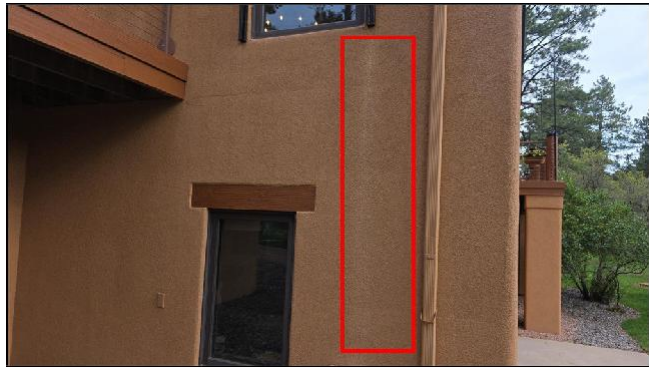
- Staining was noted in areas.

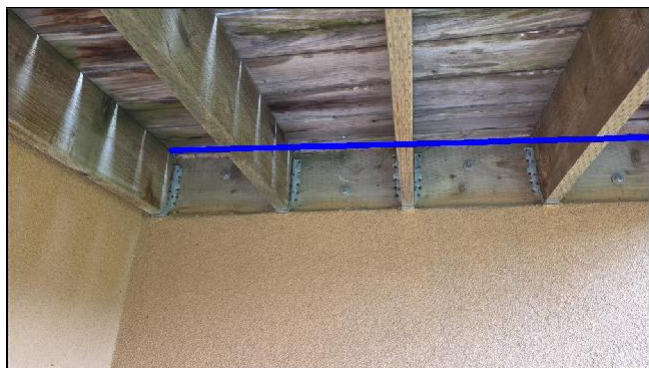
- Ledger appears to be missing the proper flashings or flashings appear to be inadequate as installed. Install or repair ledger flashing including end dams where needed. Seal all deck framing sides and along bottom edges where they penetrate the EIFS/MSV. See detail 3.13 & 3.14.

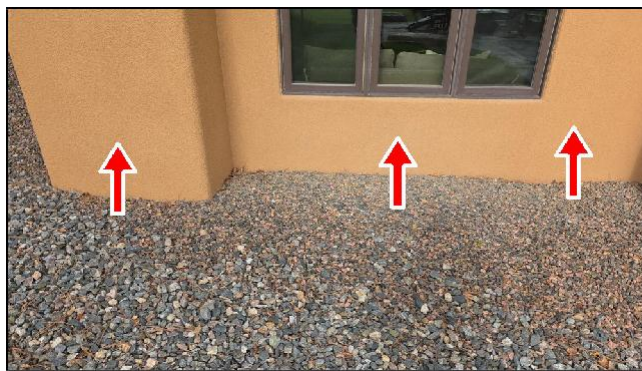
- The walls are below grade in several locations. EIFS walls should finish four inches above grade (landscaping). To resolve this issue, the landscaping needs to be rearranged so the foundation is exposed or the bottom of the walls raised. See detail 3.6.

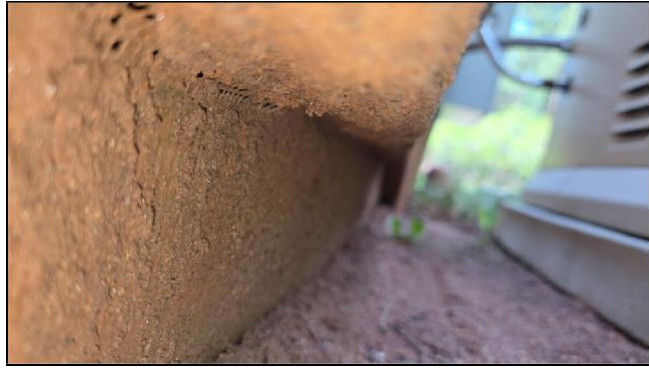
- The wall cladding is in contact with the decking. Stucco manufacturer's call for the wall cladding to finish two inches above all hard surfaces. Where the walls are on/below the decking, they should be raised. If wood is exposed in the process of raising the walls, weather proofing and metal flashing will need to be added to protect the wood. See detail 3.8.

- Bottom of system for reference.

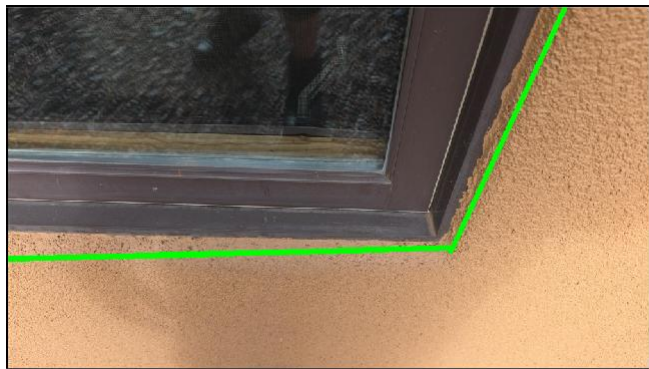
- Existing sealant appears to be aged, cracked, missing, or improper to prevent moisture intrusion at doors and windows; properly seal **ALL** windows/doors making sure to keep **ALL** weep holes unobstructed.

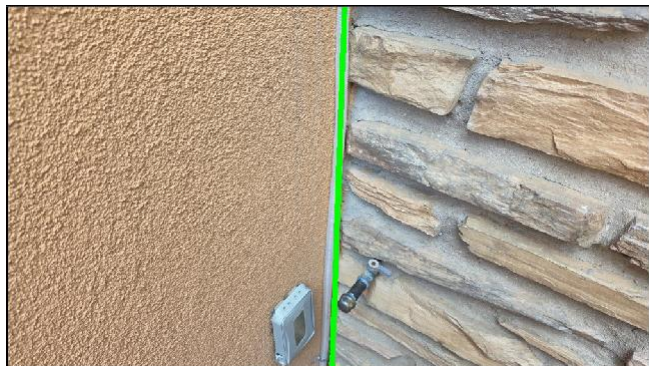
- Existing sealant appears to be aged, cracked, missing, or improper to prevent moisture intrusion at dissimilar materials; properly seal **ALL** joints between dissimilar materials.

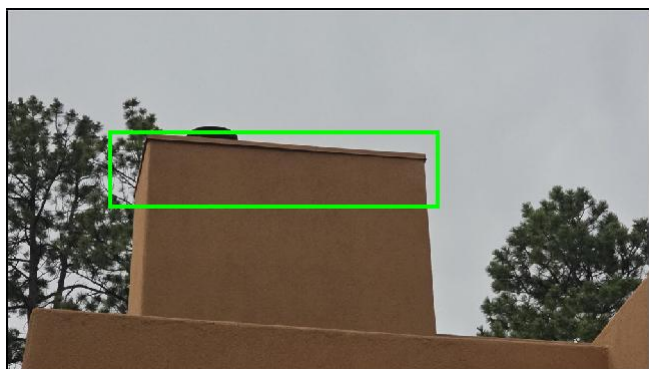
- Chimney cap flashing covers the entire top of the chimney to protect the wall cladding from moisture intrusion. The drip edge flashing does not appear to be sealed to face of the wall cladding below. The underside of this flashing should be sealed to the wall cladding below. Chapter 2 & Chapter 4, Section 5.

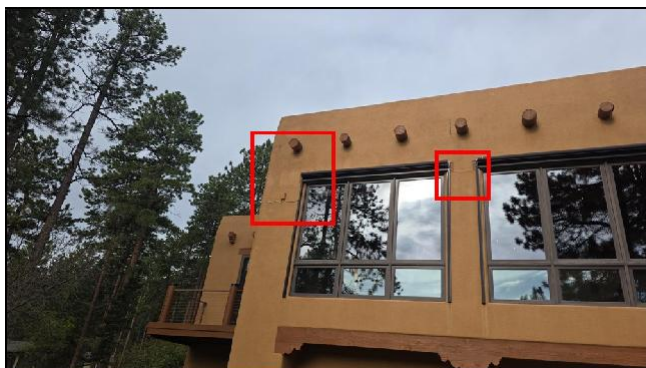
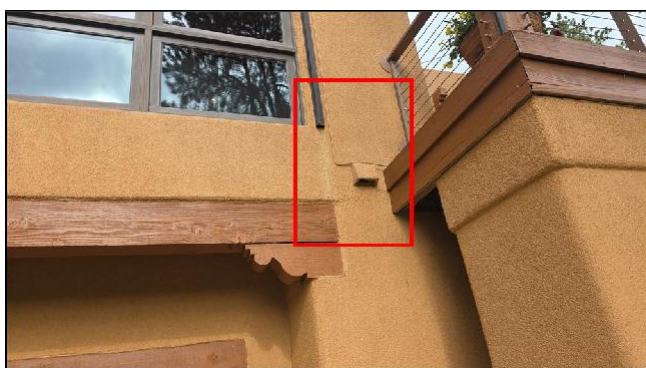
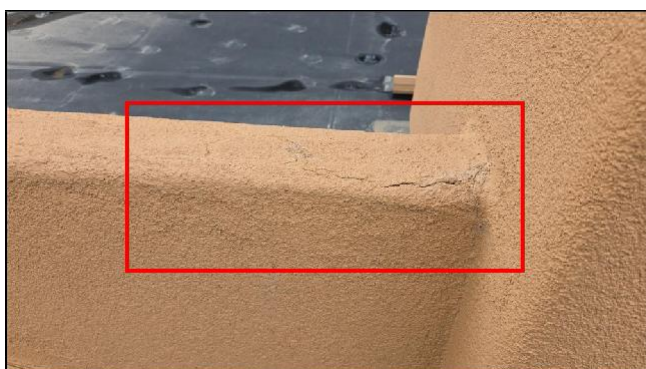
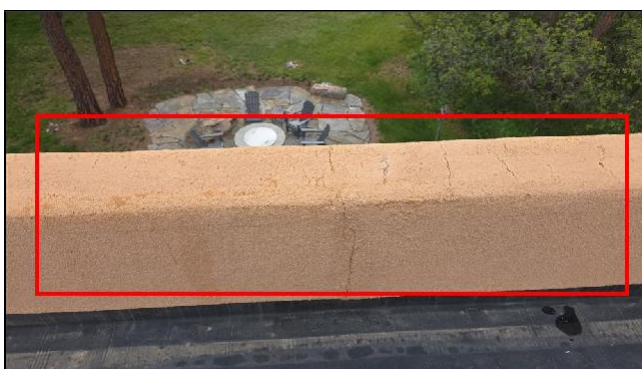
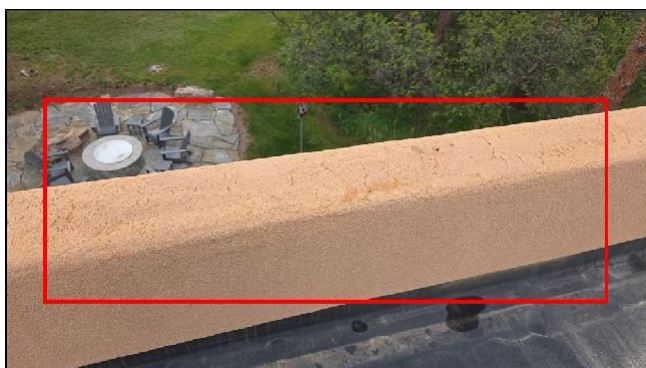
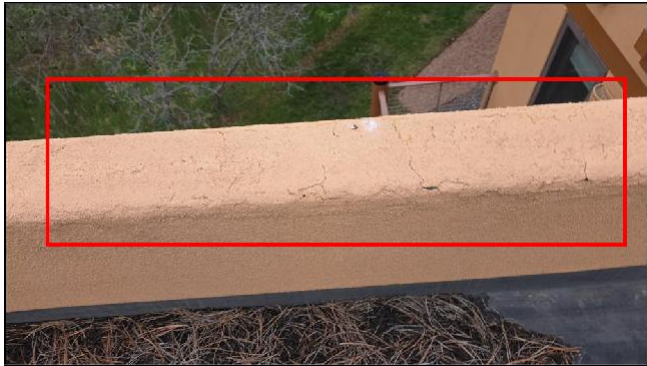
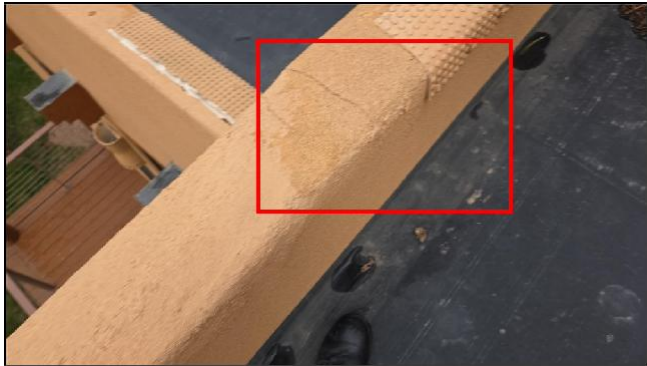
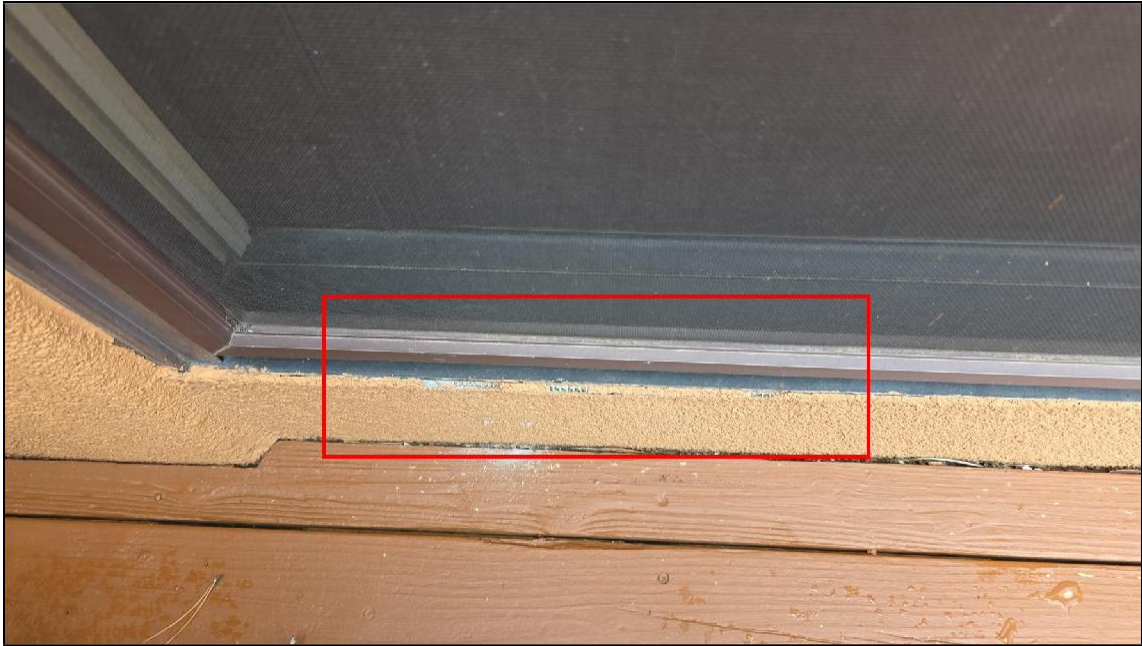
- **Damage, impact damage or exposed cracks** were noted in areas. These areas and any others discovered during repairs should be repaired to help prevent moisture intrusion. Chapter 2.

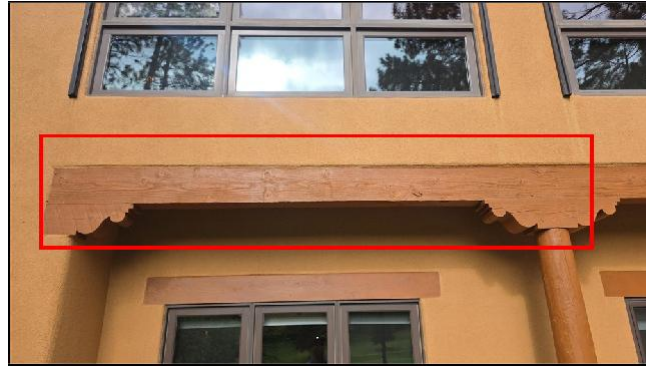
- Wood inlays appeared to be aged and dried out, these may also create avenues for moisture intrusion; remove and repair areas with stucco then properly seal all joints created.

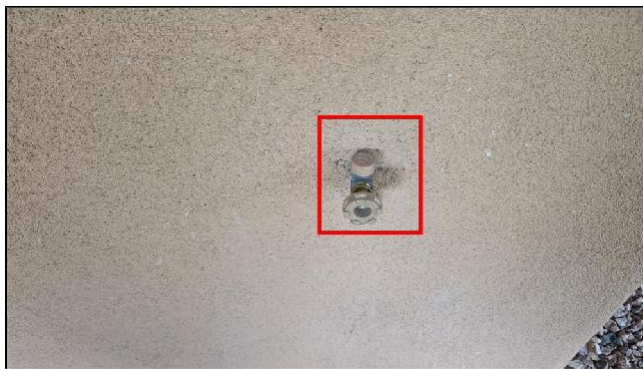
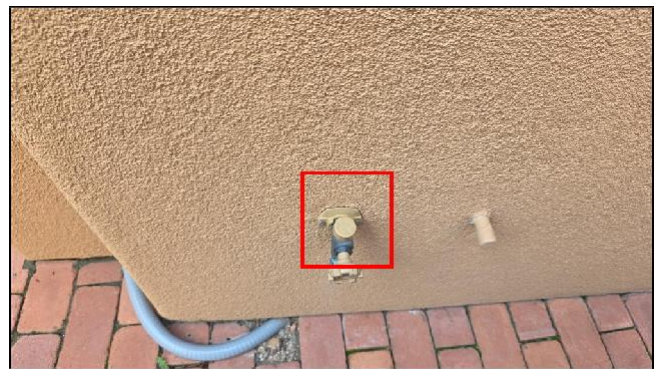
- The wall was finished around the hose bib, this can create an avenue for water intrusion. Trim back wall and install a proper stand-off then seal all created joints.

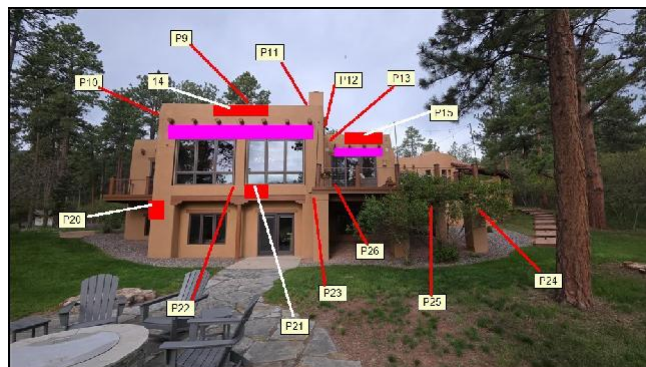
- All **PINK OUTLINED/ SHADED AREAS** were areas that were not probed, but may have deterioration present; investigate further and repair as needed.

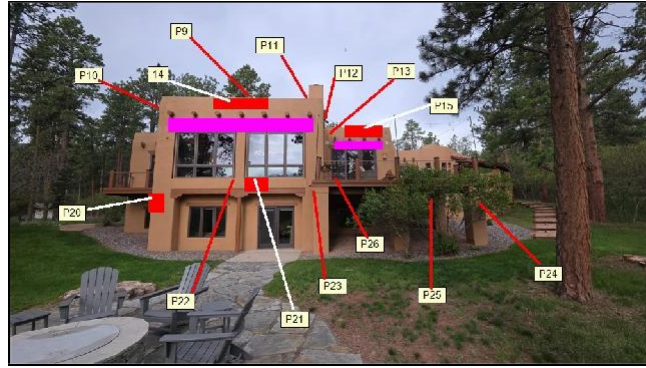
- All **RED OUTLINED/ SHADED AREAS** are indication of probable deterioration; further investigation is required.

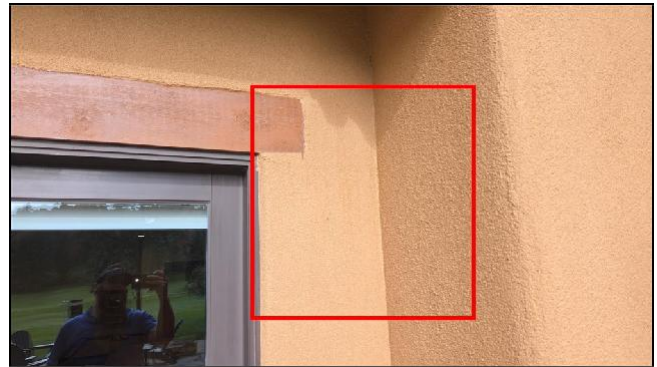
- Staining was noted in areas.

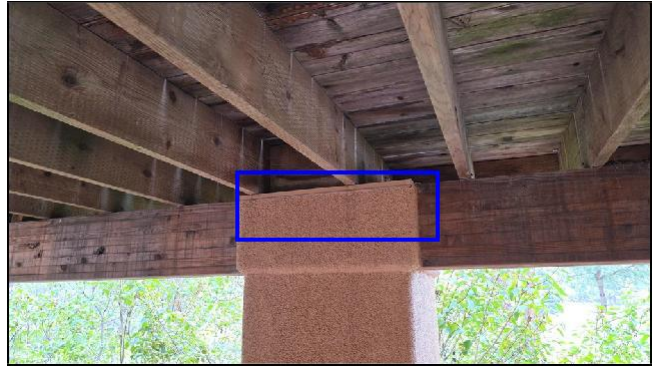
- The exposed top of the deck support beams and column caps, flashing should cover the entire top of the deck beams and column caps to protect wall cladding from moisture intrusion. As an alternative, if the client is willing to accept some additional risk of impact damage, the tops of the deck beams and column caps may be sloped and protected with a double application of water proof base coat with embedded fiberglass reinforcement in each layer. Then apply a water proof finish coat. Finally, monitor and maintain the tops of the deck beams and column caps. See detail 3.12.

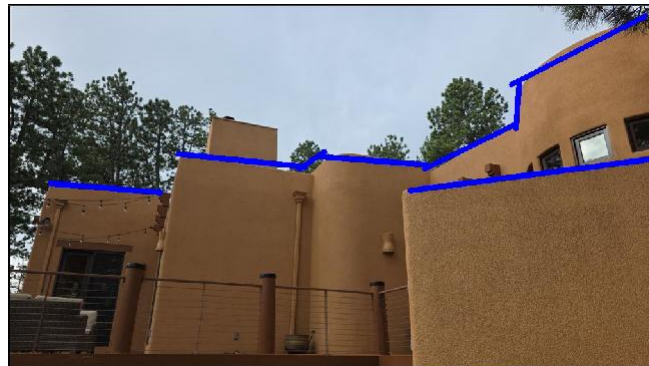
- Parapet wall or column cap flashing should cover the entire top of the parapet walls and column caps to protect wall cladding from moisture intrusion. As an alternative, if the client is willing to accept some additional risk of impact damage, the tops of the parapet walls and column caps may be sloped and protected with a double application of water proof base coat with embedded fiberglass reinforcement in each layer. Then apply a water proof finish coat. Finally, monitor and maintain the tops of the parapet walls and column caps. See detail 3.12.

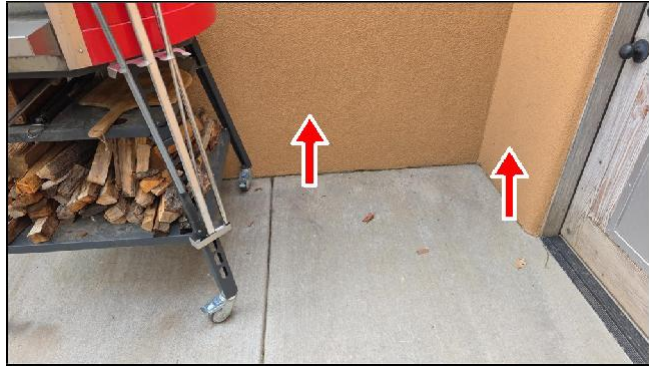
- The EIFS walls are in contact with the concrete slabs. This was a typical construction technique at the time this unit was built. The EIFS manufacturer's call for the EIFS walls to finish 2 inches above all hard surfaces, concrete slabs. Where the walls are on/below concrete slabs, they should be raised. If wood is exposed in the process of raising the walls, weather proofing and metal flashing will need to be added to protect the wood. This area was not protected so it is recommended to raise the wall and properly finish the bottom of the system.

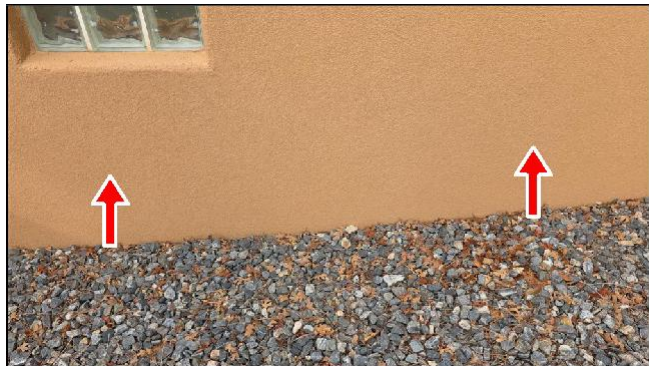
- The walls are below grade in several locations. EIFS walls should finish four inches above grade (landscaping). To resolve this issue, the landscaping needs to be rearranged so the foundation is exposed or the bottom of the walls raised. See detail 3.6.

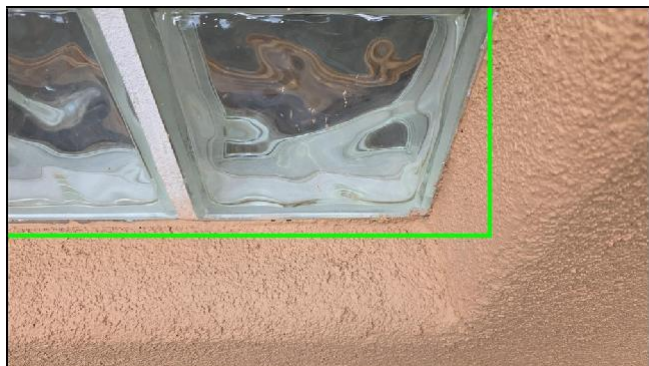
- Existing sealant appears to be aged, cracked, missing, or improper to prevent moisture intrusion at doors and windows; properly seal **ALL** windows/doors making sure to keep **ALL** weep holes unobstructed.

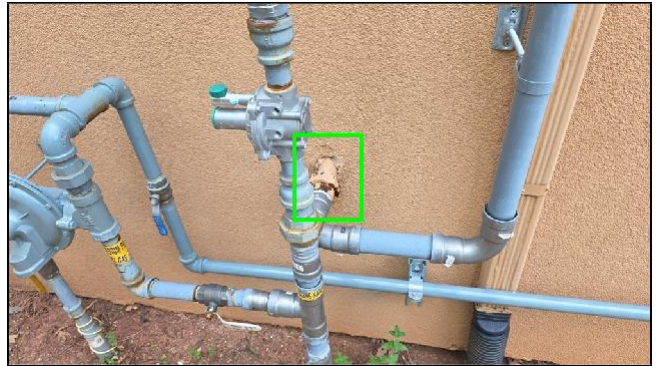
- Existing sealant appears to be aged, cracked, missing, or improper to prevent moisture intrusion at dissimilar materials; properly seal **ALL** joints between dissimilar materials.

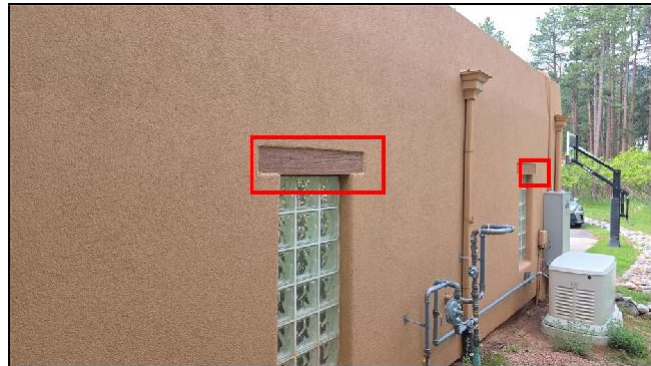
- Wood inlays appeared to be aged and dried out, these may also create avenues for moisture intrusion; remove and repair areas with stucco then properly seal all joints created.

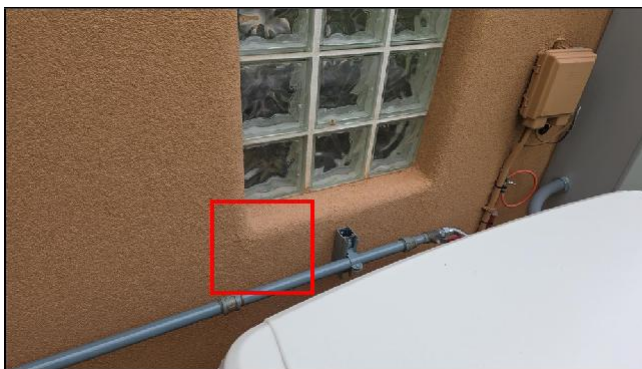
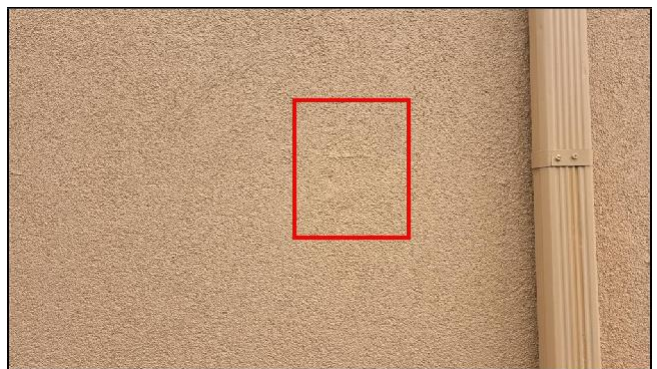
- Damage, impact damage or exposed cracks** were noted in areas. These areas and any others discovered during repairs should be repaired to help prevent moisture intrusion. Chapter 2.

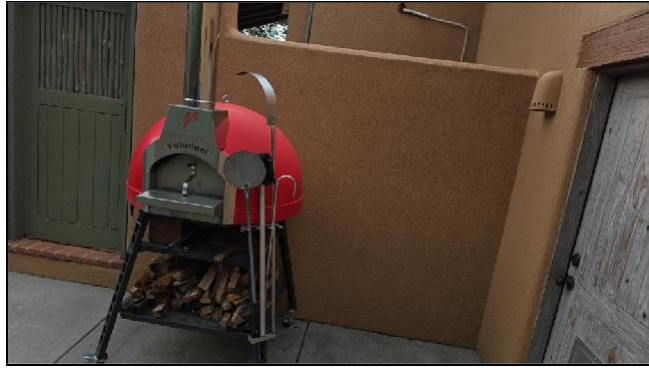
- Staining was noted in areas.

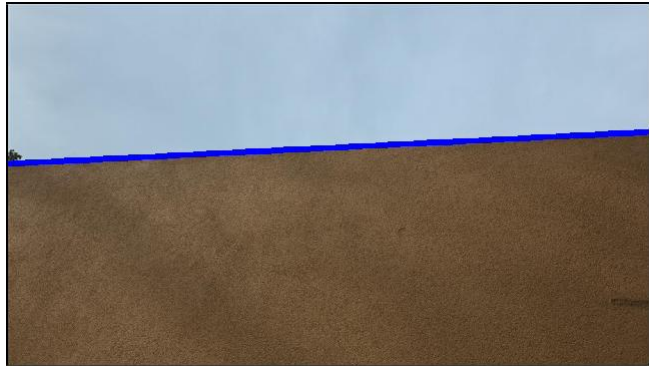
- Parapet wall or column cap flashing should cover the entire top of the parapet walls and column caps to protect wall cladding from moisture intrusion. As an alternative, if the client is willing to accept some additional risk of impact damage, the tops of the parapet walls and column caps may be sloped and protected with a double application of water proof base coat with embedded fiberglass reinforcement in each layer. Then apply a water proof finish coat. Finally, monitor and maintain the tops of the parapet walls and column caps. See detail 3.12.
