# Barrier EIFS Stucco Inspection Report

**Property Address:**  
1234 Pine Lane  
Anywhere, CO 80121

**Huffman Inspections Colorado, Inc.**

| <b>Date:</b> 5/28/2026 | <b>Time:</b> 08:00:00 AM | <b>Report ID:</b> 20260528JM1 |

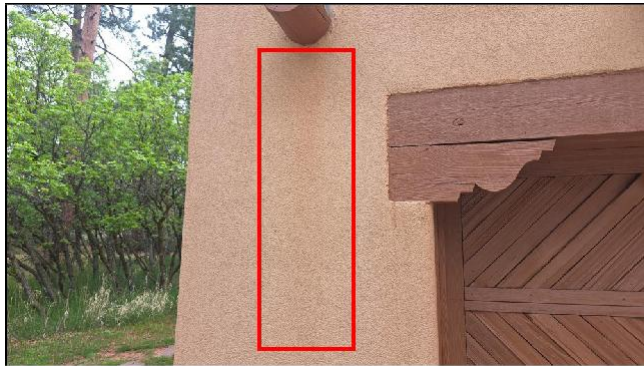
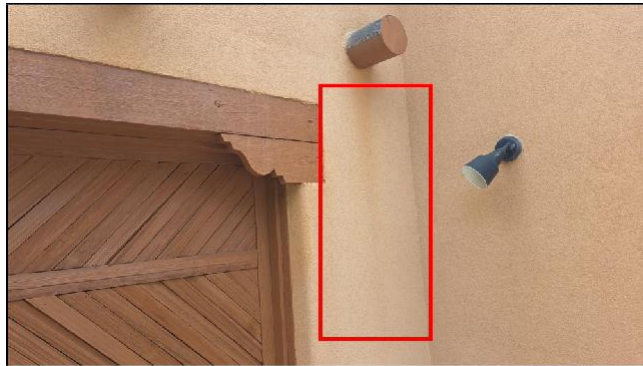
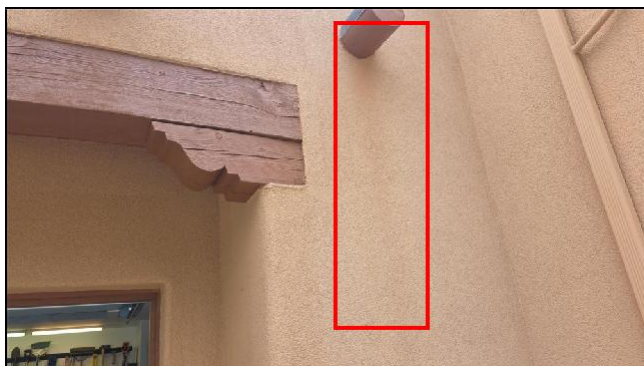
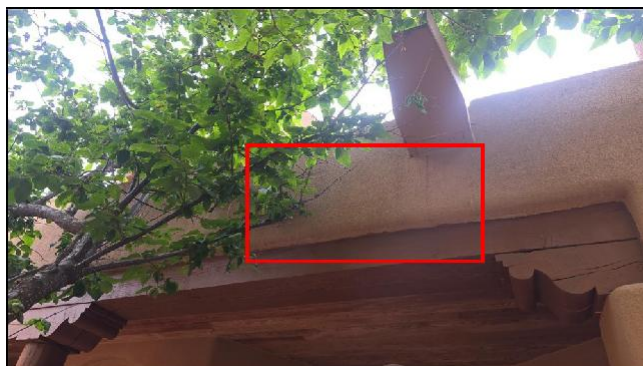
- Staining was noted in areas.

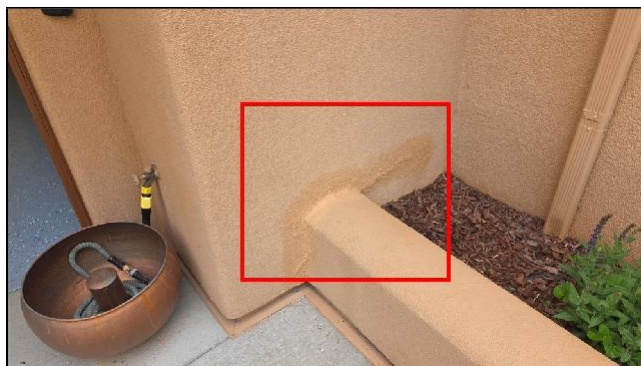
- Repairs noted in various areas; monitor.

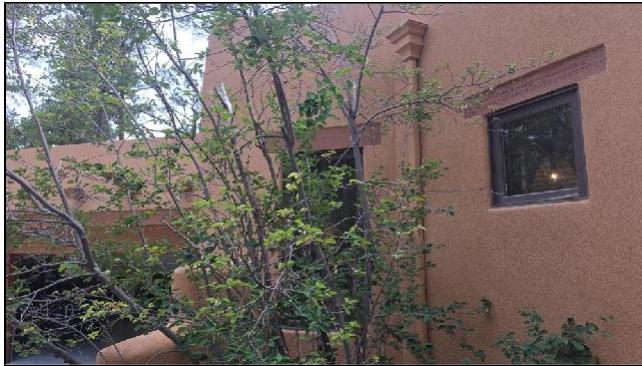
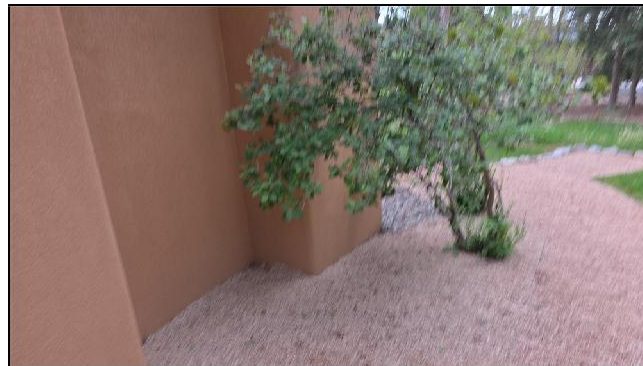
- All shrubbery and vegetation should be pruned back 18-24 inches from the house as it retains moisture in the immediate area and inhibits its evaporation.

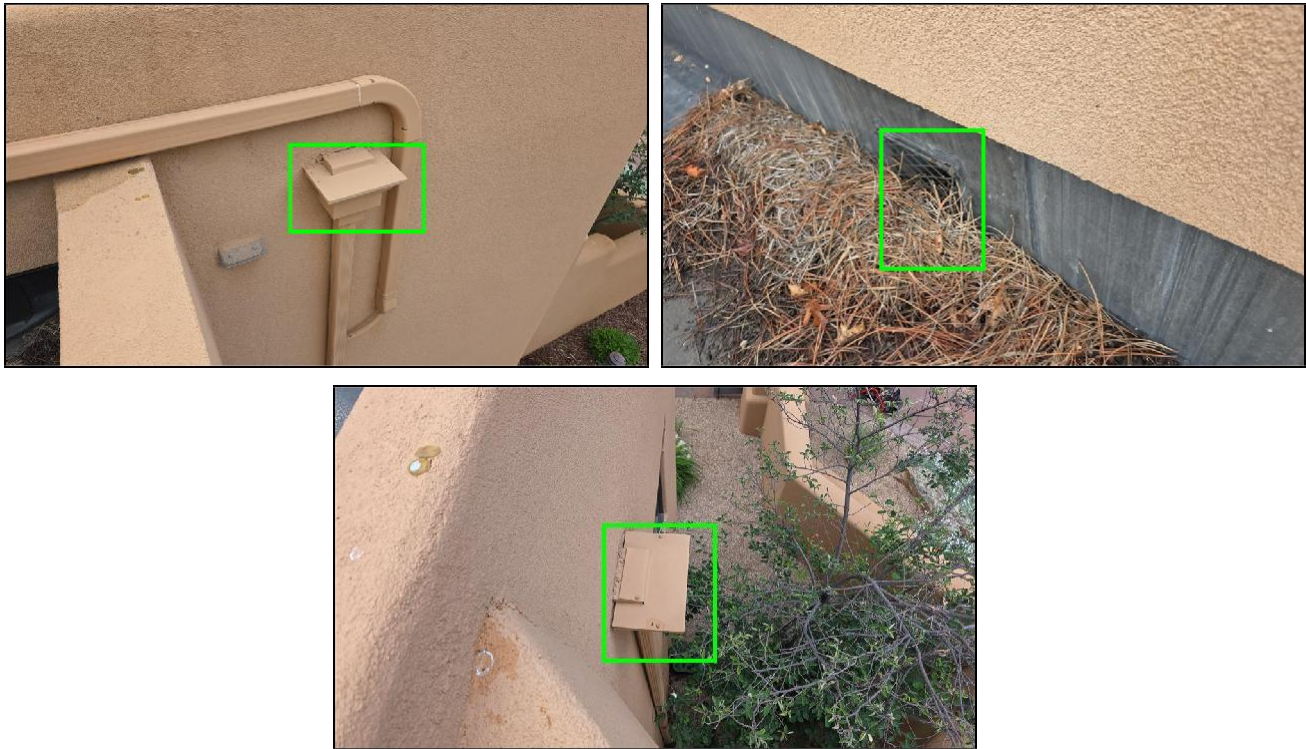
- Scuppers were not properly sealed; seal all joints.

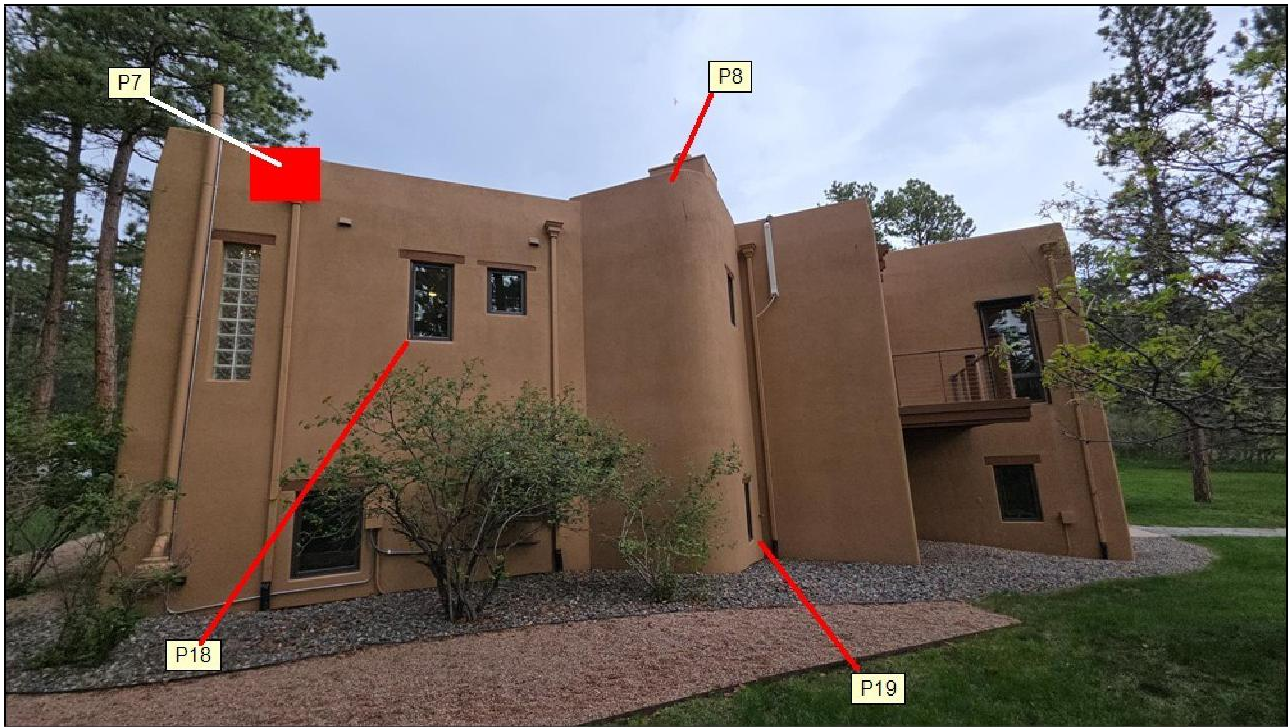
Right elevation

P7: Probe 7 Tramex 25, Delmhorst 34.5%, SRT 16# through. Wall scanned dry, probed very wet, and the substrate tested **badly deteriorated** under damage at parapet wall.

P8: Probe 8 Tramex 30, Delmhorst 18.9%, SRT 48# 1/16". Wall scanned dry, probed moist, and the substrate tested firm under damage at parapet wall.

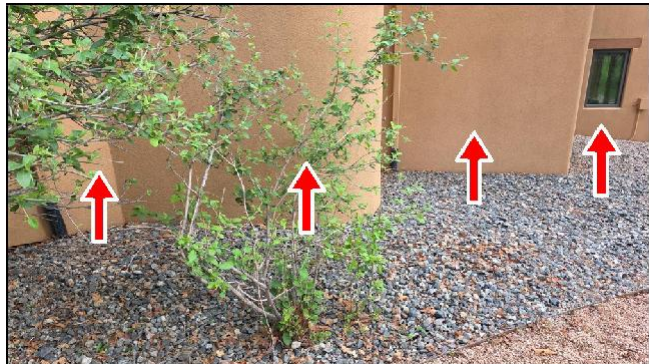
- The walls are below grade in several locations. EIFS walls should finish four inches above grade (landscaping). To resolve this issue, the landscaping needs to be rearranged so the foundation is exposed or the bottom of the walls raised.

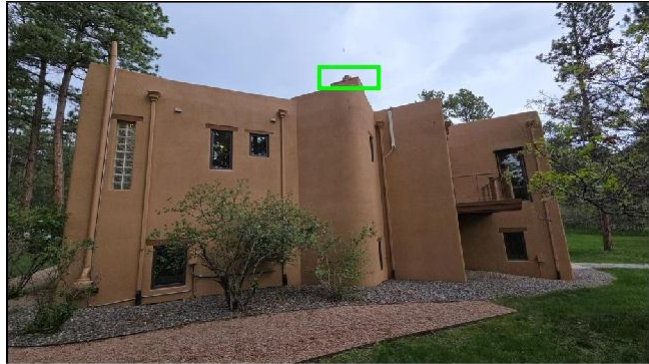
- Chimney cap flashing covers the entire top of the chimney to protect the wall cladding from moisture intrusion. The drip edge flashing does not appear to be sealed to face of the wall cladding below. The underside of this flashing should be sealed to the wall cladding below. Chapter 2 & Chapter 4, Section 5.

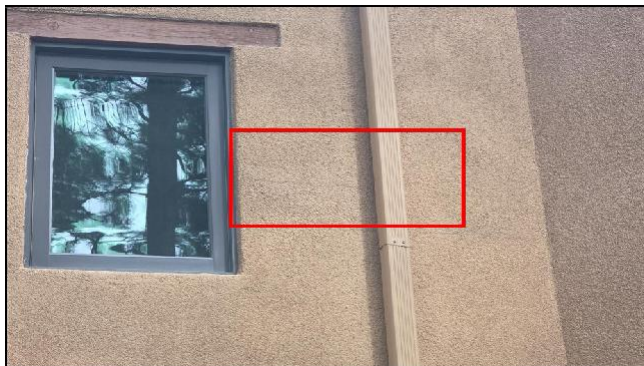
- Damage, impact damage or exposed cracks** were noted in areas. These areas and any others discovered during repairs should be repaired to help prevent moisture intrusion. Chapter 2.

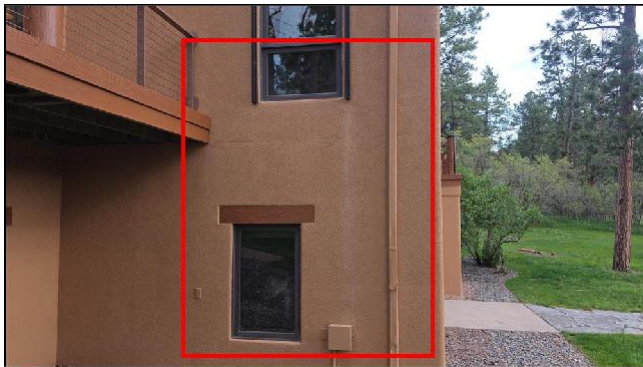
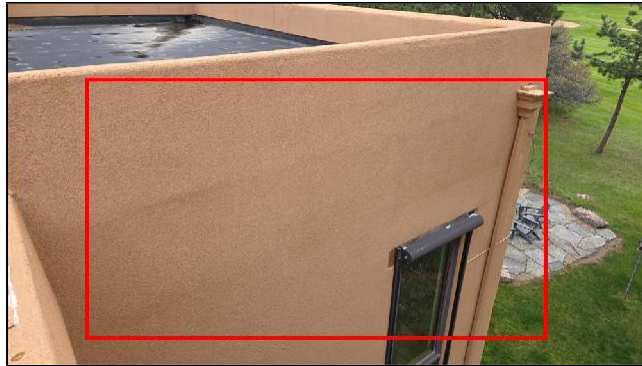
- Seams between EPS panels were visible through the finish coat; repair and sealant any joints created during repairs.

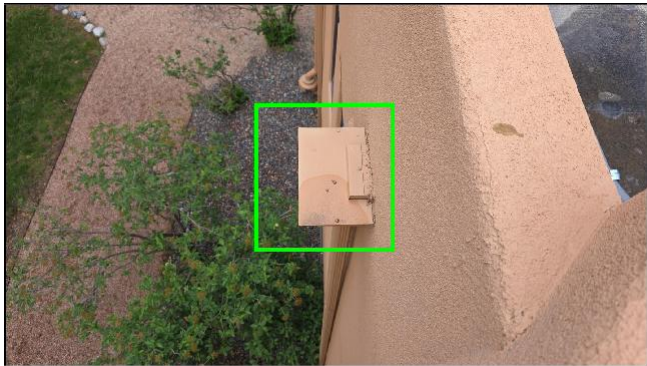
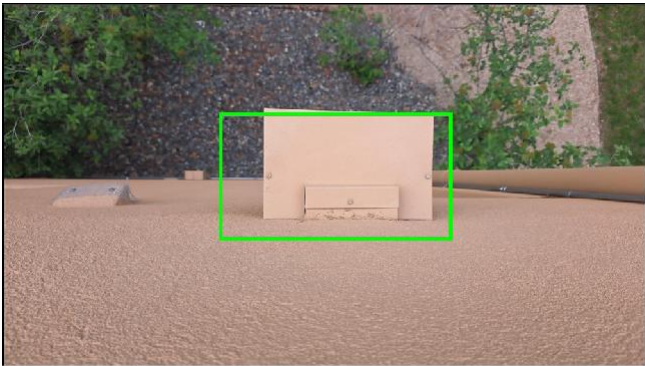
- Scuppers were not properly sealed; seal all joints.

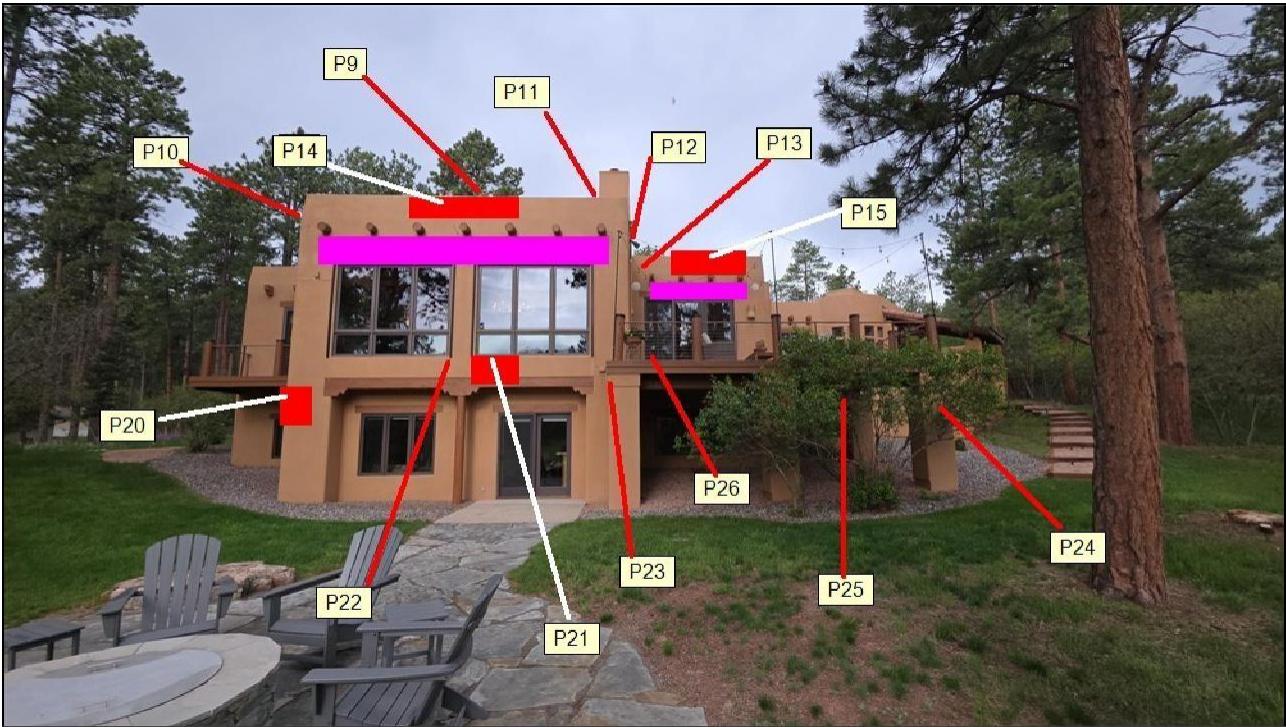
Rear elevation

P10: Probe 10 Tramex 25, Delmhorst 17.6%, SRT 48# 1/16". Wall scanned dry, probed moist, and the substrate tested firm at parapet wall.

P11: Probe 11 Tramex 20, Delmhorst 9.8%, SRT 48#. Wall scanned dry, probed dry, and the substrate tested firm under damage at parapet wall.

P14: Probe 14 Tramex 25, Delmhorst 40.0%, SRT 0# through. Wall scanned dry, probed saturated, and the substrate tested **badly deteriorated** under damage at parapet wall.

P15: Probe 15 Tramex 35, Delmhorst 23.0%, SRT 48# through. Wall scanned dry, probed wet, and the substrate tested **deteriorated** under damage at parapet wall.

P20: Probe 20 Tramex 35, Delmhorst 23.8%, SRT 0# through. Wall scanned wet, probed wet, and the substrate tested **badly deteriorated** under left deck connection.

P21: Probe 21 Tramex 25, Delmhorst 30.9%, SRT 48# 1/4". Wall scanned dry, probed wet, and the substrate tested **deteriorating** under left corner of right large window.

P23: Probe 23 Tramex 20, Delmhorst 6.0%, SRT 48#. Wall scanned dry, probed dry, and the substrate tested firm under damage near deck connection.

P24: Probe 24 Tramex 20, Delmhorst 10.2%, SRT 48#. Wall scanned dry, probed moist, and the substrate tested firm at right column.

P26: Probe 26 Tramex 25, Delmhorst 17.1%, SRT 48#. Wall scanned dry, probed moist, and the substrate tested firm under left center of door.

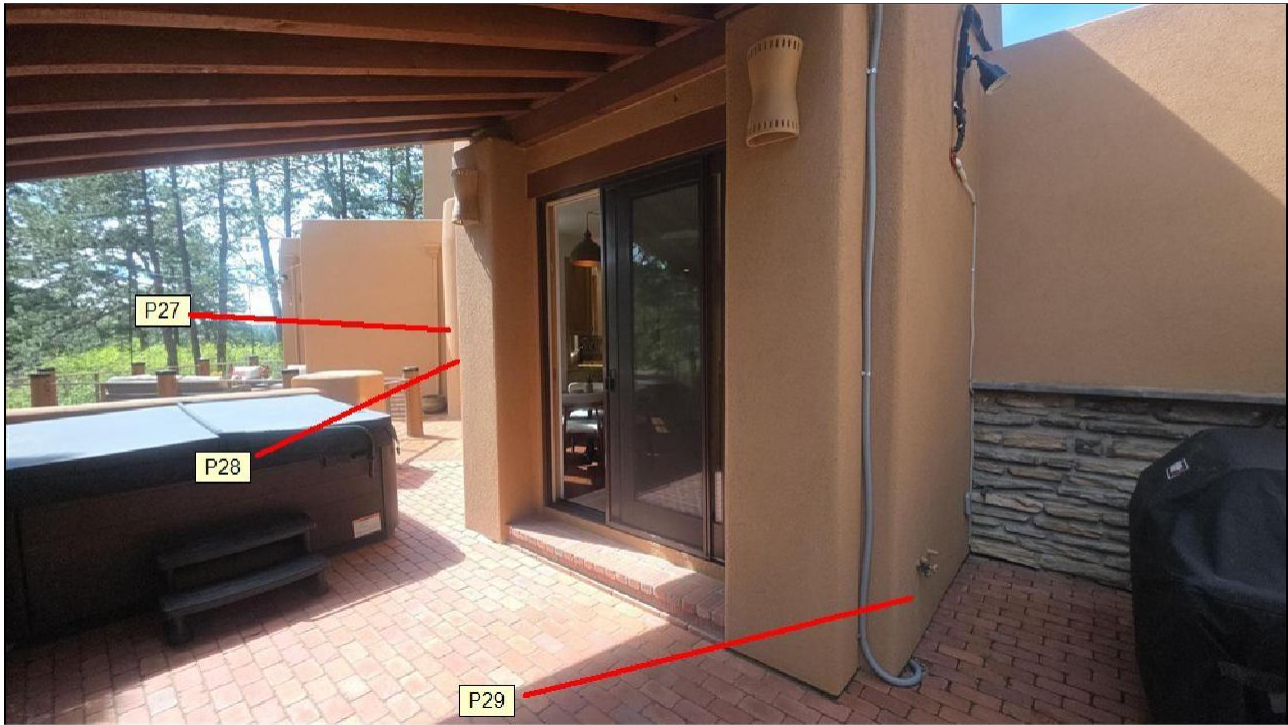
Rear elevation hot tub area

P28: Probe 28 Tramex 20, Delmhorst 11.0%, SRT 48#. Wall scanned dry, probed moist, and the substrate tested firm under left corner of window by the hot tub. Not visible in overview photo.

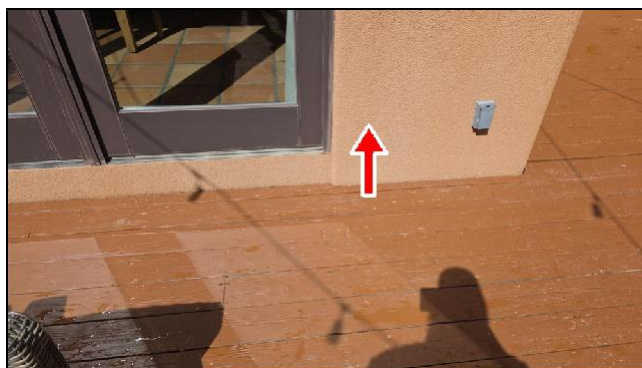
- The wall cladding is in contact with the decking. Stucco manufacturer's call for the wall cladding to finish two inches above all hard surfaces. Where the walls are on/below the decking, they should be raised. If wood is exposed in the process of raising the walls, weather proofing and metal flashing will need to be added to protect the wood. See detail 3.8.

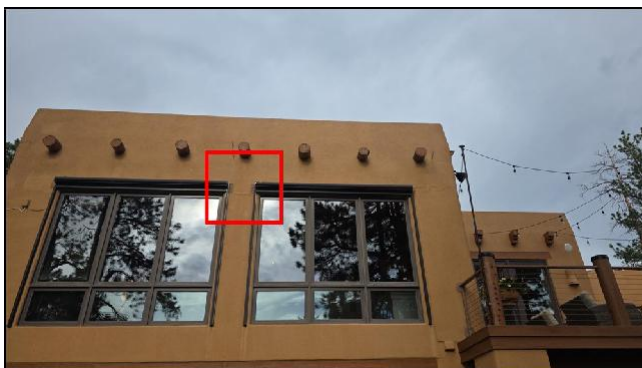
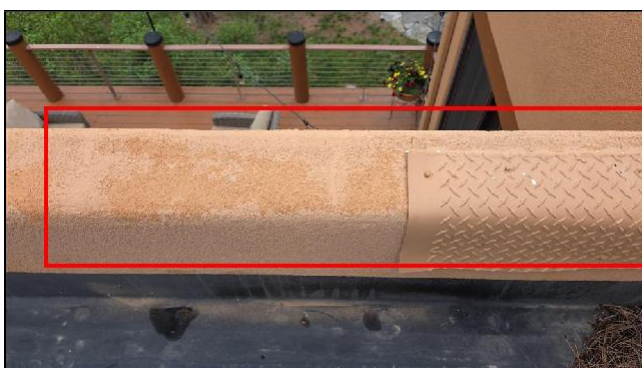
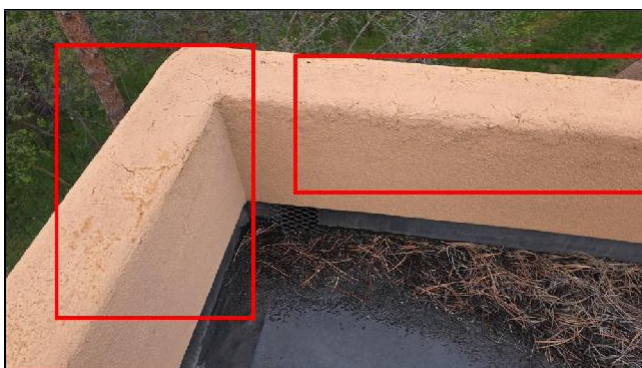
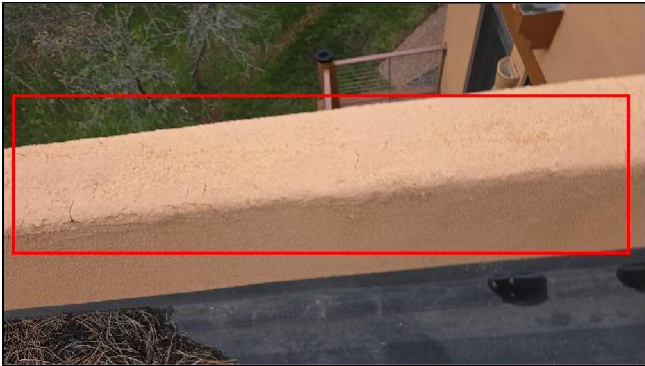
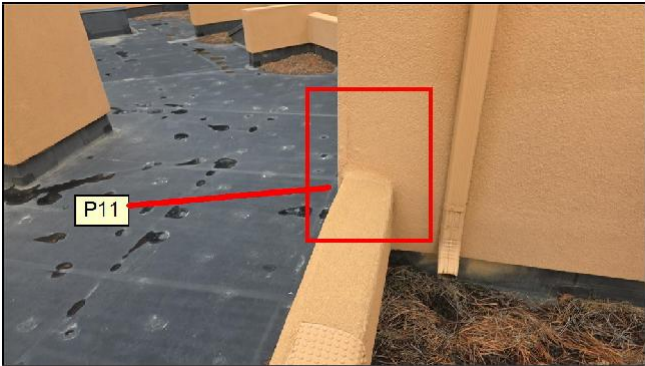
- **Damage, impact damage or exposed cracks** were noted in areas. These areas and any others discovered during repairs should be repaired to help prevent moisture intrusion. Chapter 2.

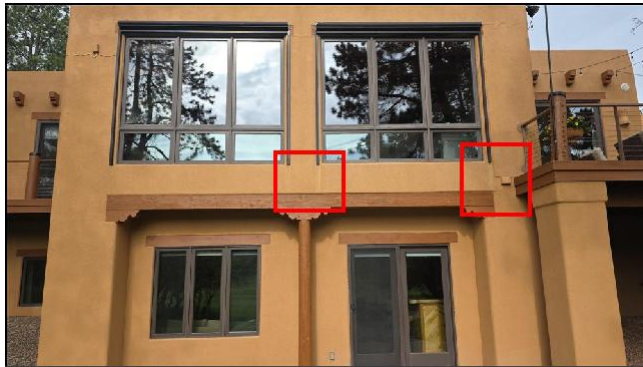
- Staining was noted in areas.

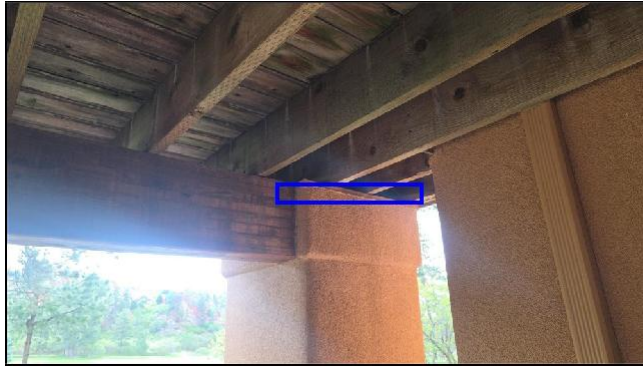
- The exposed top of the deck support beams and column caps, flashing should cover the entire top of the deck beams and column caps to protect wall cladding from moisture intrusion. As an alternative, if the client is willing to accept some additional risk of impact damage, the tops of the deck beams and column caps may be sloped and protected with a double application of water proof base coat with embedded fiberglass reinforcement in each layer. Then apply a water proof finish coat. Finally, monitor and maintain the tops of the deck beams and column caps. See detail 3.12.

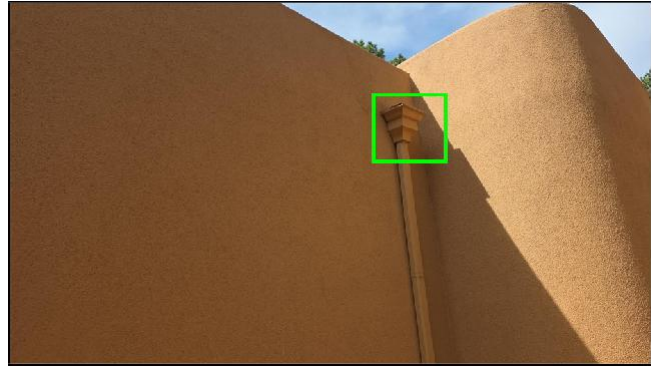
- Scuppers were not properly sealed; seal all joints.

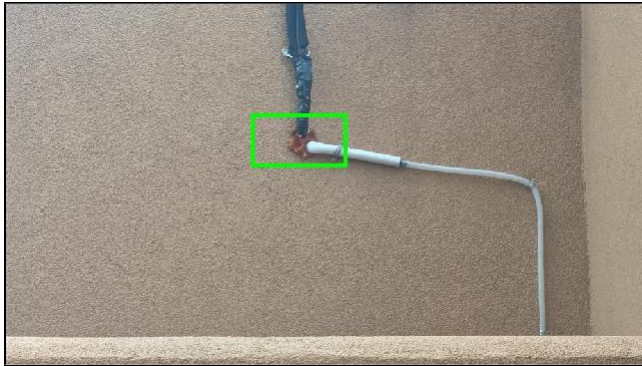
- Existing sealant appears to be aged, cracked, missing, or improper to prevent moisture intrusion at dissimilar materials; properly seal **ALL** joints between dissimilar materials.
